Safety Representatives report .

Assault on Police - 10th June 2017 -South Wales Police area.

The following is the report from the assaulted officer and his concerns about the cage in the new long wheel base Mercedes Sprinter van currently being issued.

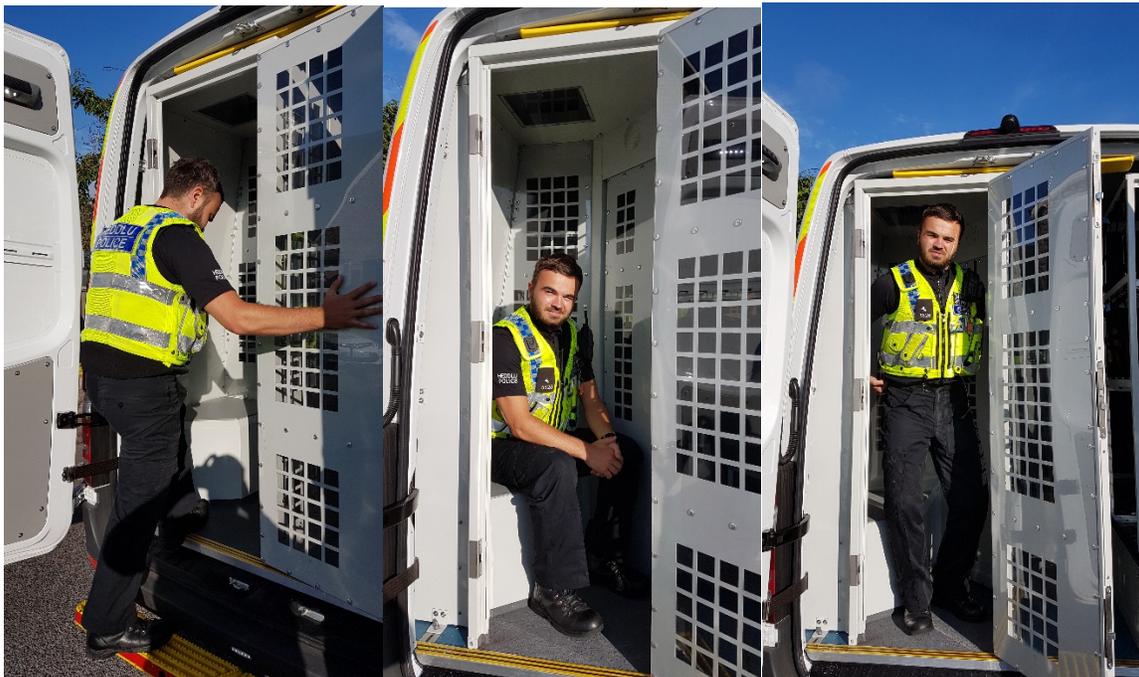
In order to demonstrate pictorially I have used two of my team colleagues. One is around 5'8" in height and medium build, the other is around 6'2" and larger build.

The current cage has been placed into the rear nearside corner of the van.

The main entry door is revealed when you open the rear nearside door. This noticeably has a very small aperture compared to the cages installed in the previous station van.

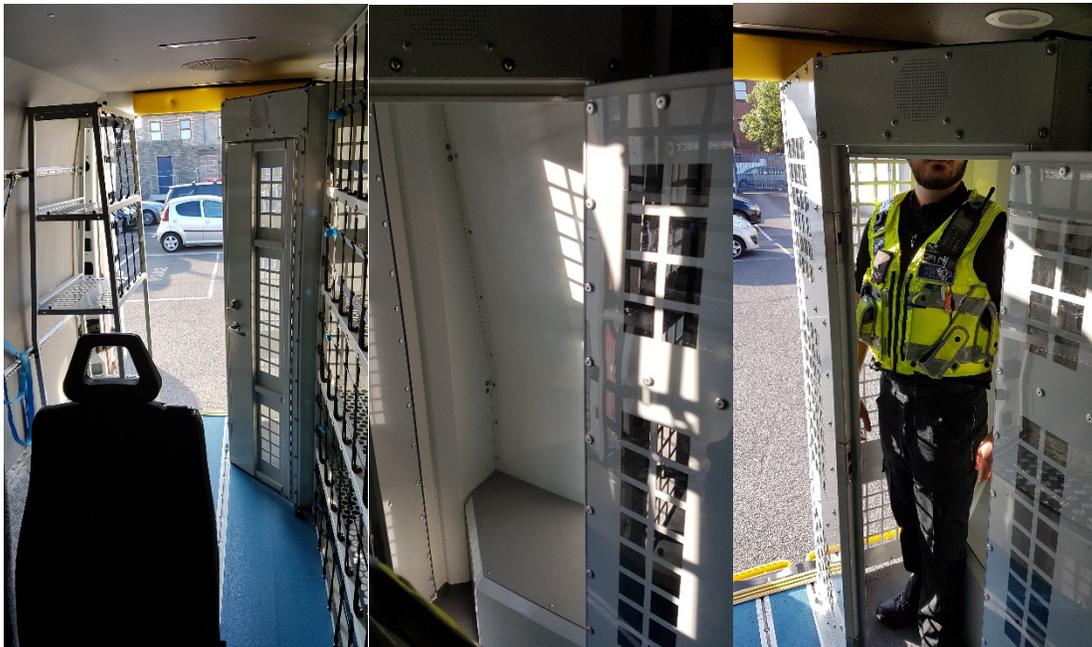
There is a step which you have to utilise to get into the cage and as the detainee tries to negotiate this there is an opportunity for them to “donkey” kick out at officers if they are standing too close. Kicks would be aimed at the chest area or even higher, which has been highlighted in the incident report.

There is also an opportunity for detainees to “lock out” if not handcuffed and splay their arms across the aperture to resist being placed inside. Even with handcuffs on there is an opportunity for detainees to use their shoulders against the sides of the aperture to resist access.

There is a small seat inside the cage and due to the small dimensions and the fact that detainees sit on it facing the rear cage door, it is too easy for detainees to hold onto the sides or push against the back and use leverage to kick out, whilst standing or sitting, at anyone who may be opening the rear cage door. Considerable force can be generated in this manner.

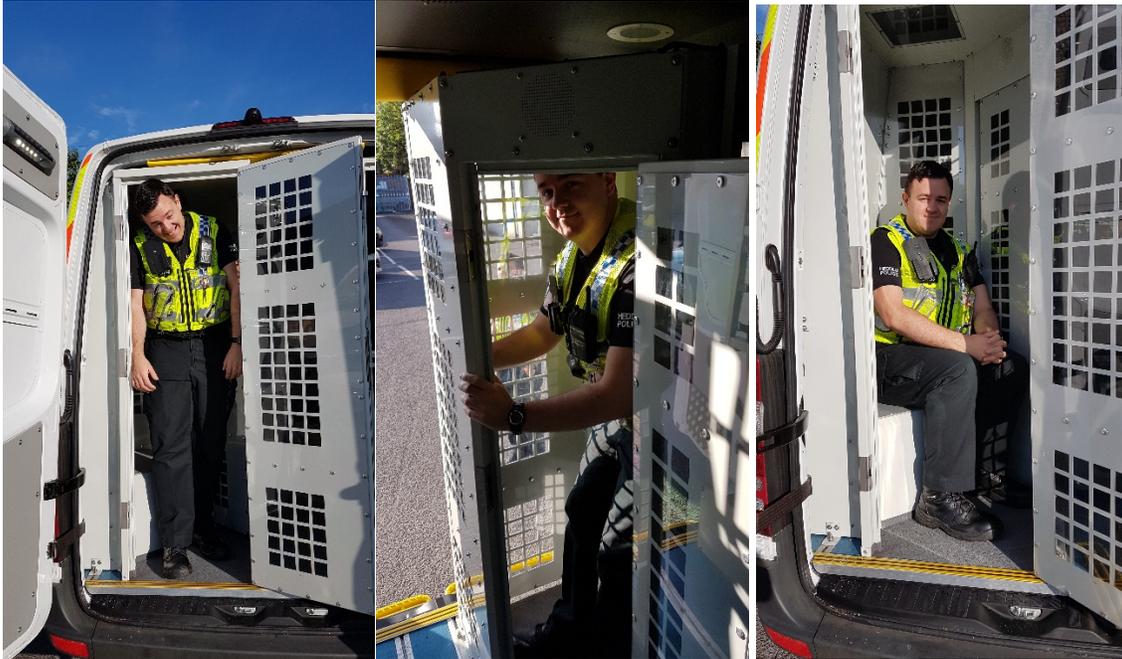
Height restriction

The cage is also restrictive for taller detainees as demonstrated by my taller colleague and the top of the inner cage door is also much lower and poses a risk of head injury to officers assisting to put detainees in or out and also a risk to the detainees.

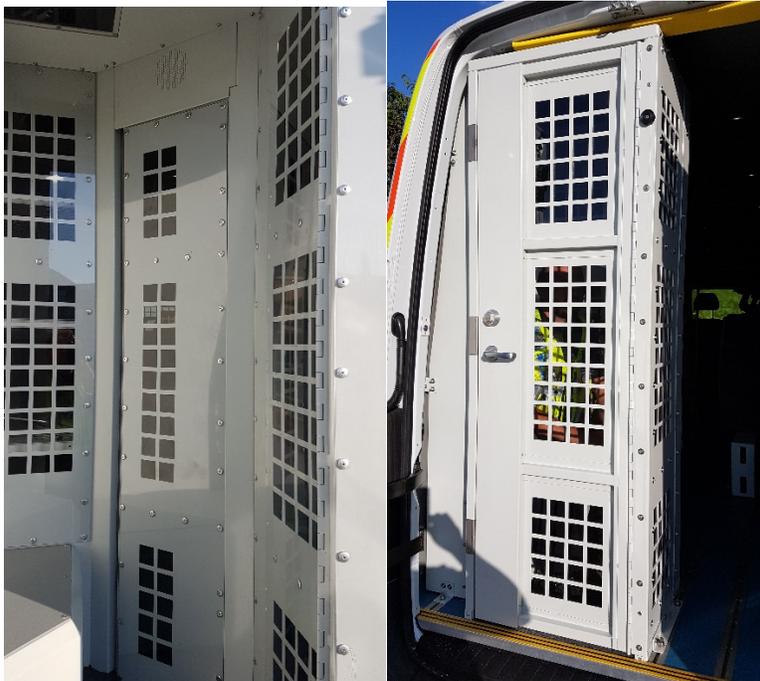
Entering the van from the side door the cage is on the right as you walk down the aisle. There is a second door which opens into the inside van space, however this is even narrower and even the smallest officer had to get in by shuffling to the side.

Some forces have a policy that a detainee in the rear cage of a van has to be escorted by at least two officers i.e. the driver and one other. This is understandable due to the high risk of detainees self-harming/ attempting suicide as mentioned above. However, the design of the rear of this van doesn't allow for an officer to position themselves adequately to perform the monitoring role and as also mentioned previously the view afforded of the inside of the cage in my opinion is not adequate enough for safety.
